HAWKES POND OUTLET DAM

MA 00245

**PHASE I INSPECTION REPORT
NATIONAL DAM INSPECTION PROGRAM**

AUGUST 1978

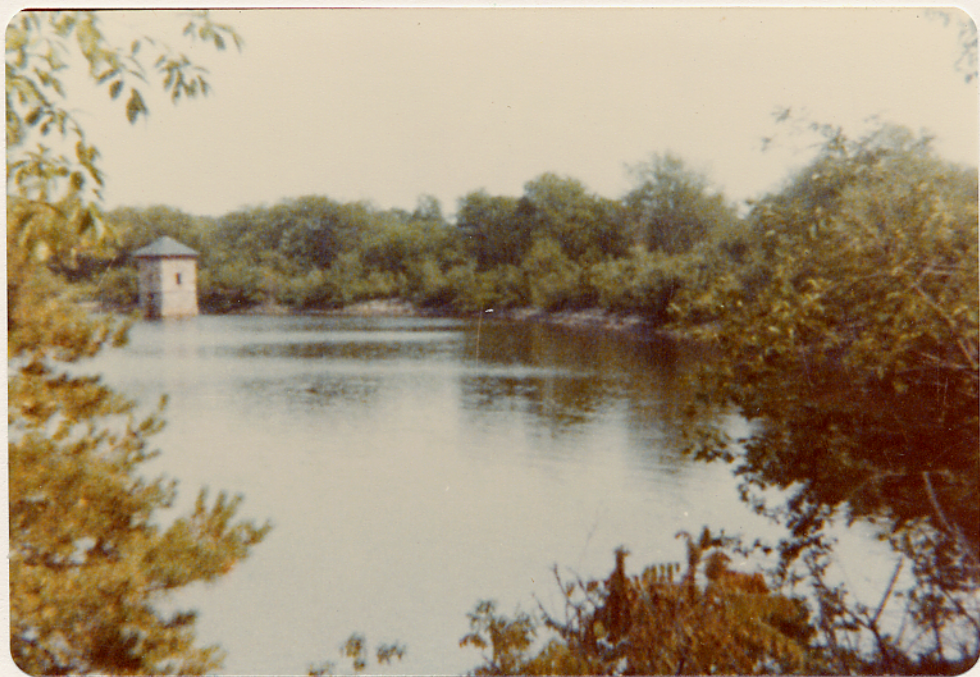
OVERVIEW PHOTO

b. Dam. The earthfill dam lies to the right of the spillway section. There is dense vegetation on the crest and upstream and downstream slope of the dam. The vegetation made close inspection impossible, however there appear to be no serious horizontal or vertical misalignments of the dam nor is there evidence of significant seepage through the dam. The dam can be considered to be in fair condition.

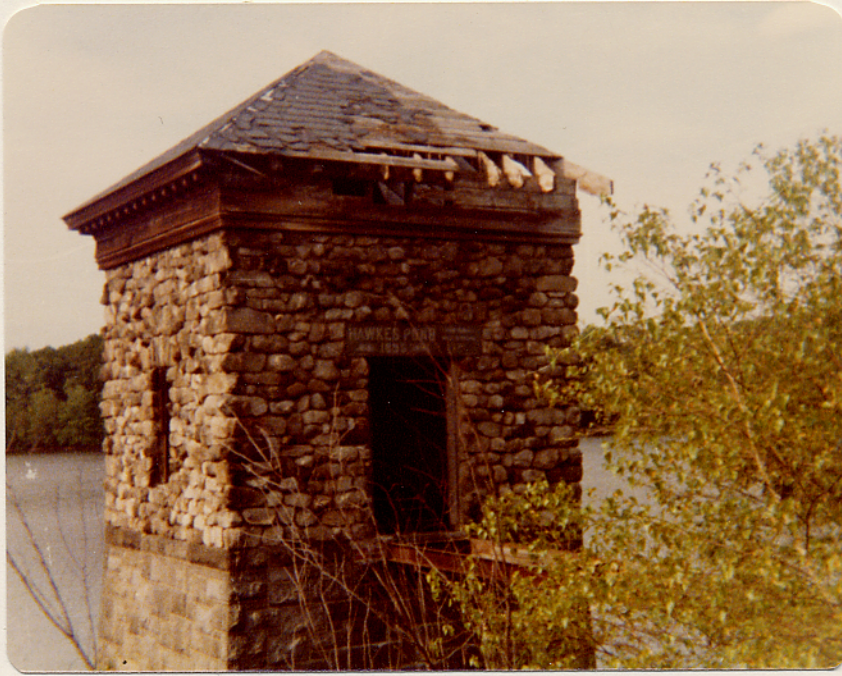
2

The outlet works are inoperable and in generally poor condition. The stone-faced gate house structure appears to be sound, although much of the roof is missing. The door is missing and there is no decking on the service bridge. It was not possible to observe the gates.

Abandoned Valve House

(5) The outlet works should be reactivated so that the reservoir can be drained without breaching the dam or its abutments. This would include repair and painting of the access bridge and the rehabilitation of the gate house and gates.

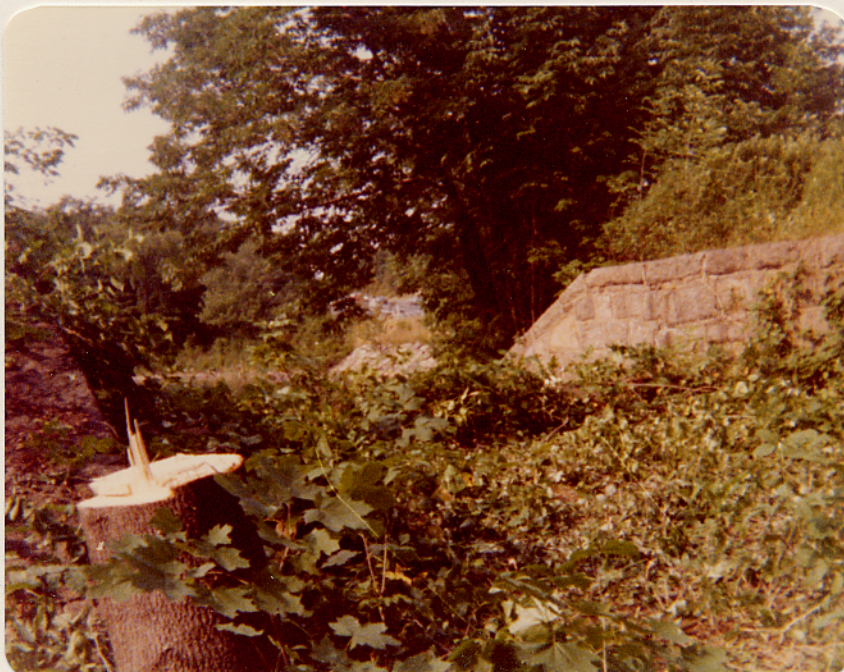
3

The dam is heavily overgrown and in fair condition. The spillway is overgrown to the extent that its capability of discharging water is seriously impaired.

c. Appurtenant Structures. The spillway is almost entirely blocked with trees and vegetation. The masonry block walls of the spillway are in fair condition but require some pointing up and general maintenance. The growth is so dense that the nature of the spillway bottom cannot be determined.

Overgrown Spillway Channel

(3) The sides and especially the bottom of the spillway will undoubtedly require repairs. The exact nature of the repairs to the bottom is not known as the bottom is completely overgrown and no drawings of the spillway exist.
